# **Operational Evaluation Test Report on Beaver Micro-Vegetation Cutter**

**April 2005**

Institute for Defense Analyses  
4850 Mark Center Drive  
Alexandria, VA 22311-1882

**Humanitarian Demining Program Office**  
Night Vision and Electronic Sensors Directorate  
Attn: AMSRD-CER-NV-CM-HD  
10221 Burbeck Road  
Fort Belvoir, VA 22060

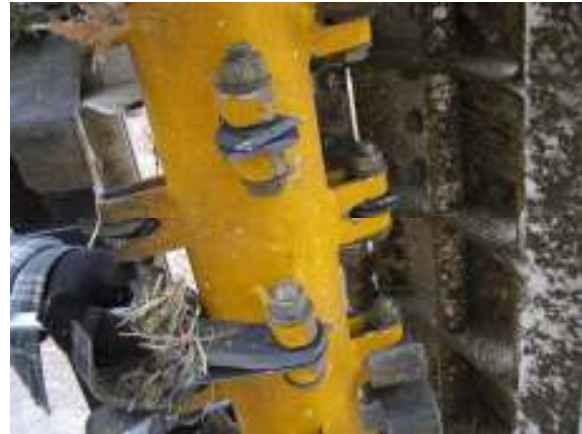
**Figure 4: Broken Pre-Test Cutters**

- The cutters were notched when they hit the inside bottom edge of the U-shaped cutter mounts. The notch propagated cracks and broke the cutters. The solution was to grind off the sharp shoulder on the U-shaped mount.
- Seven cutters were broken. The time to replace all seven of the cutters was 15 minutes.
- There was a delay between the operator command and the response of the MVC or the cutter. This led to over-control input from the operator. The solution was to adjust the SRCS to shorten the signal-response time.
- The operator had to keep the cutter in the line of sight to know the relation of the cutter to the ground.

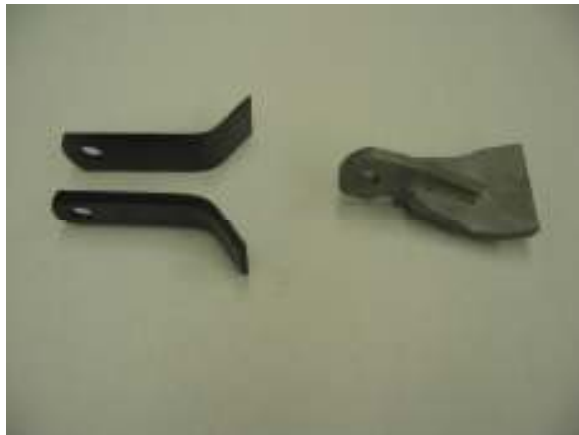
**Figure 5: Pre-Test & Operational Evaluation Cutters**

- **Vegetation Cutter:** The vegetation cutter was designed and fabricated in the Humanitarian Demining Program's fabrication shop at Ft. Belvoir. A second hydraulic pump is mounted in the Beaver to power the cutter. As a result of the high failure rate of the commercially procured cutting blades used during the pre-evaluation test, new cutters were designed and manufactured in the fabrication shop and used throughout the operational evaluation test. Figures 3 and 4 show the damage sustained by the two-piece cutters used during the pre-evaluation test (wt. = 434 grams); Figure 5 shows the pre-test cutters (left) and the T-1 steel machined cutter (right) used during the

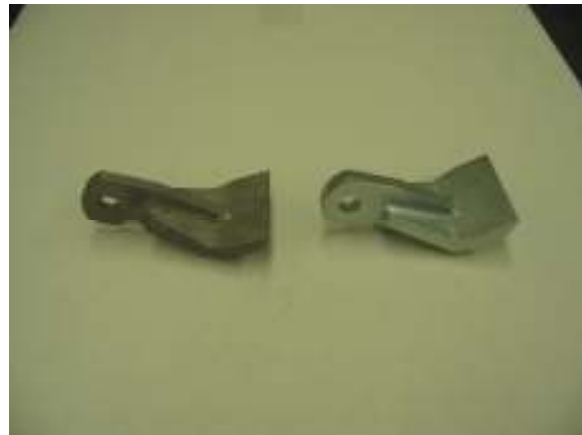
**Figure 6: Machined and Cast Operational Evaluation Cutters**

operational evaluation test (wt. = 634 grams); and Figure 6 shows the machined cutter (left) and the 4130 heat-treated cast alloy cutter (right) that will be used on future fabricated vegetation cutters (wt. = 756 grams). The weights and materials are shown for each of the cutters as an indicator of each cutter's strength and durability.

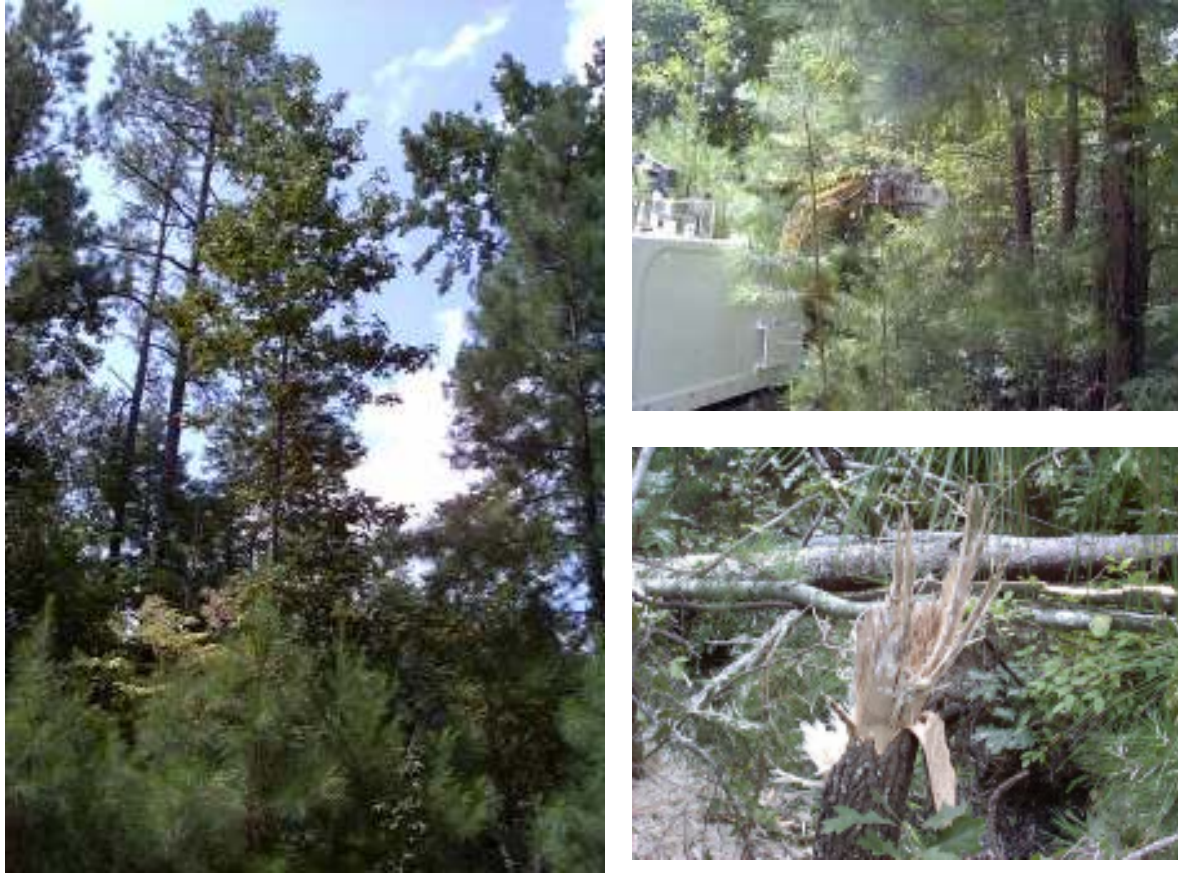
**Figure 17: Tree to be Cut (left), Cutting (top right), Stump (bottom right)**

A Category 4 deciduous, maple variety tree, 12 to 14 meters high and 15.4 cm in diameter, was selected for the Category 4 cutter operational evaluation test. The procedure followed with this tree was slightly different than followed with the two smaller trees in the Category 2 and 3 test. The tree was topped by cutting through the tree with the cutter at a height of 3–4 meters. The top fell behind the tree and the portion of the trunk left standing was then chewed down to ground level. Total time for this operation was 10 minutes. See Figure 17.

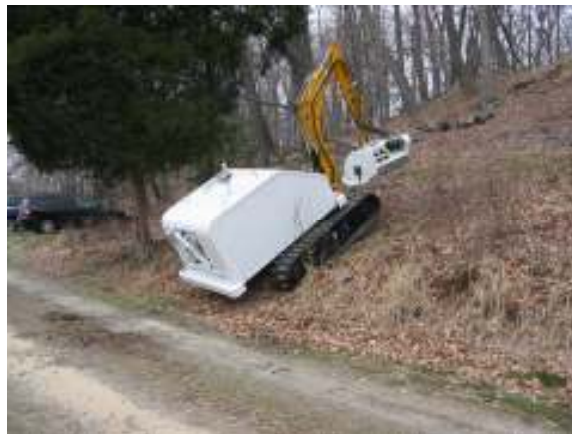
**Figure 21: Angle of Approach/Departure**

This test was only conducted with the Beaver. The surface cover for the slope climbed was loose soil and gravel intermittently covered with leaf mulch, sparse grass, and low shrubs. The approach and departure angle negotiated, without losing traction, was 32.5 degrees. The Beaver continued to climb the hill, with subsequent grades up to 28 degrees, to a height of about 60 feet without any problems. See Figure 21.

- Hydraulic reservoir filler cap leaked oil in angle of approach and departure test. It is recommended that a redesign be considered.
- The gap at the top of the Duck's front windscreen allows dust to blow in and into the operator's face.
